ITEM DETAILS						
Name of Item	Sandstone Culvert, approx 200m south of Meurants Lane					
Other Name/s Former Name/s						
Item type (if known)	Built

NSW State Heritage Inventory form

PROPOSED HERITAGE ITEM 7

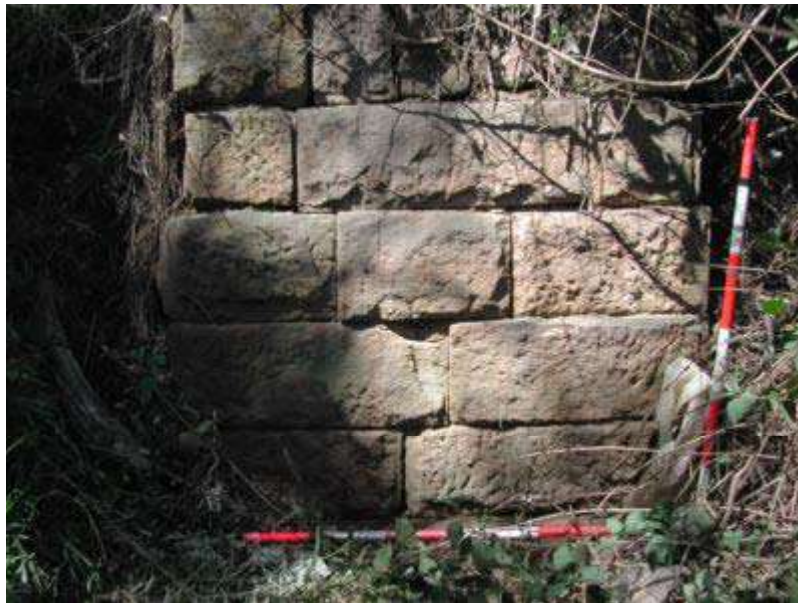
The west side of the culvert on Old Windsor Road south of Meurants Lane. Note the clay pipe in the lowest course beneath the range pole.

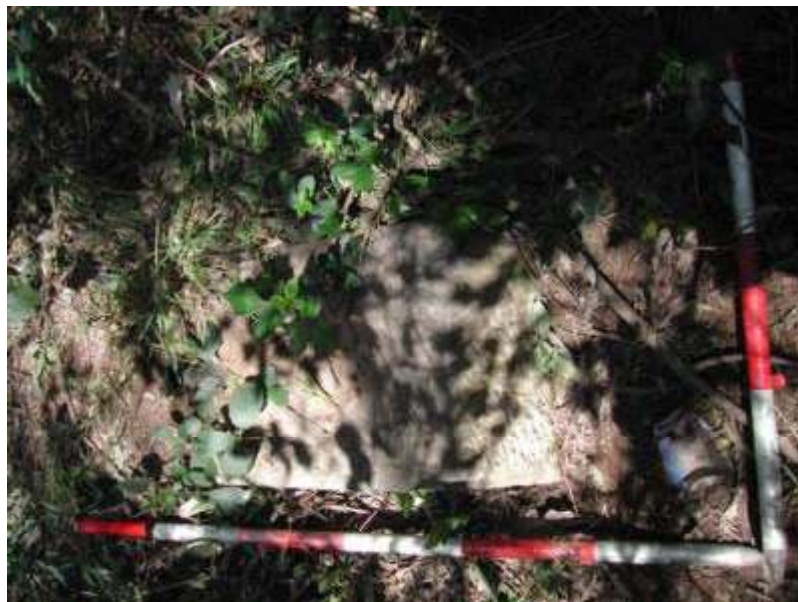
DESCRIPTION			
Designer	Unknown		
Builder/ maker	Unknown		
Physical Description	Very old sandstone culvert on both sides of a disused portion of the Old Windsor Road. Constructed of sparrow-pecked, hammer-dressed sandstone. The mouth of the culvert on the eastern side (upstream) of the road has collapsed to three courses from the top. A clay pipe runs under the base of the road at ground level. It was recorded as having four courses visible in 1993 (Casey & Lowe). The west side of the culvert is in good condition, although the general area is infested with weeds such as Lantana and blackberry that may compromise the structural integrity of the items by growing in cracks etc. Seven courses visible although the first course is almost obscured by silt. It appears as though the lintel has moved across to south on the western side.		
Physical condition and Archaeological potential	Original condition assessment: 'East side of the culvert (upstream) has partially collapsed although the sandstone blocks are still in excellent condition. West side of the culvert is in excellent condition. Clay pipe (1993-94) in good condition.' (Last updated: 8/03/2005.) 2007-08 condition update: 'Poor (east) - Fair (west).' (Last updated: 17/4/09.)

The east side of the culvert showing the collapsed top three courses. Despite the failure of the culvert, the sandstone blocks are still in good condition and should be reinstated.
