6 Honeman Close, Huntingwood NSW

Photographic archival record report of former service station

Prepared for Cadway Projects Pty Ltd | 21 August 2017

Report J17099RP1 | Prepared for Cadway Projects Pty Ltd | 21 August 2017

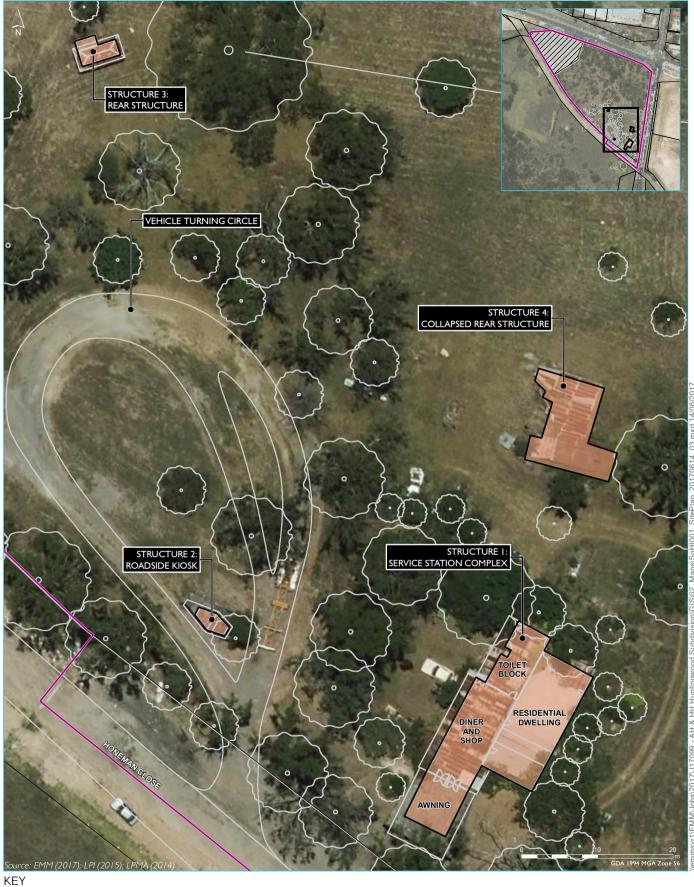
Site plan 6 Honeman Close, Huntingwood NSW Photographic archival record report of former service station Figure 3.1

The former service station comprises a number of structures and features that are in the south-east corner of the project area facing Honeman Close. These are described below and shown in Figure 3.1.

These buildings are in a very poor and dilapidated condition. Most of the windows are broken and many external walls are partially destroyed. All of the entrances to the diner and shop and residential dwelling are boarded to prevent access. The inside of the diner and shop was viewed from one of the broken windows and it was clear that the inside was hazardous and unsafe to enter.

The roadside kiosk is in poor condition as it has no windows, most of the ceiling has collapsed and the motorised roller doors are partially missing on its eastern side and completely removed on its western side.

This building is in a poor condition with numerous graffiti signs and large sections of wall missing from the structure.

A collapsed timber structure with a corrugated iron roof is situated to the rear of the former service station complex. The visible unmilled timber supports suggest that this building was a storage shed.
