Item Details

Name
Blacktown Railway Signal Box

Address
George Street BLACKTOWN NSW 2148

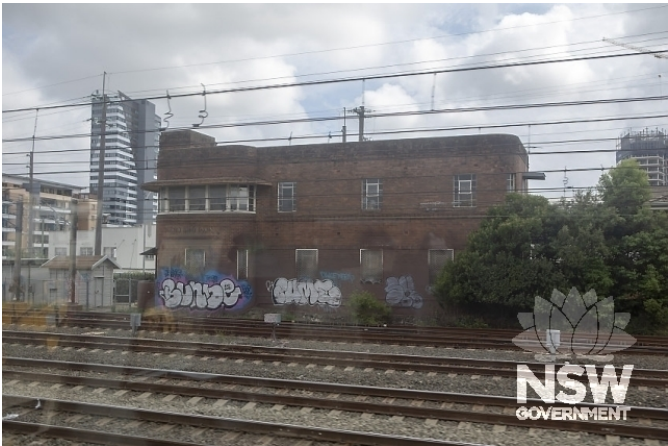
External: Blacktown signal box is a 'type S' post war version of the elevated power boxes. It is one of four similar signal boxes, the others are Clyde, Granville and Auburn. Blacktown signal box is no longer used for signalling purposes since its conversion to offices for communications and control systems consultants.

Constructed of polychromatic face brick and designed in the Functionalist style, it is a two storey former electric power signal box with stairwells in a three storey tower. The box has curved walls facing the railway lines. The parapet does not continue along the northern (street) frontage. Horizontal banding in the brickwork is created by projecting brick courses. Cantilevered reinforced concrete awnings over the first floor ribbon windows are a dominant feature. The ground floor windows are steel framed while top floor windows are timber framed and sashed. The tower windows are long strips of square panes with orange and clear glass, although these have been covered on the outside and are not visible externally. All windows have security grills.
