ITEM DETAILS						
Name of Item	Sandstone Culvert, approx 200m south of Meurants Lane					
Other Name/s Former Name/s						
Item type (if known)	Built

NSW State Heritage Inventory form

PROPOSED HERITAGE ITEM 7

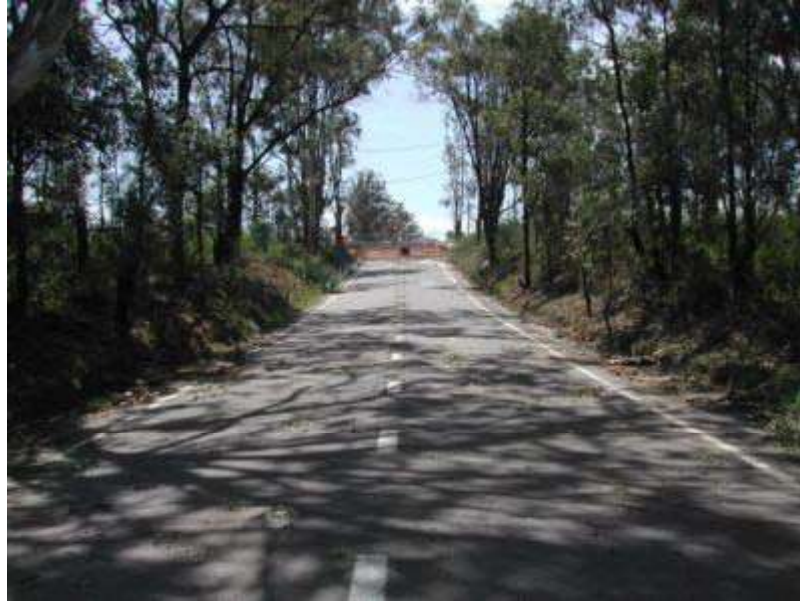
The stretch of former Old Windsor Road at the approximate location of the culvert. Meurants Lane to the north can be seen in the background. The new road alignment is to the east at the right of the photo.
